V-22 *Osprey* Hydraulic System  
(D-2002-114)

Department of Defense  
Office of the Inspector General

SUBJECT: Evaluation Report on V-22 *Osprey* Hydraulic System  
(Report No. D-2002-114)

**Report No. D-2002-114**

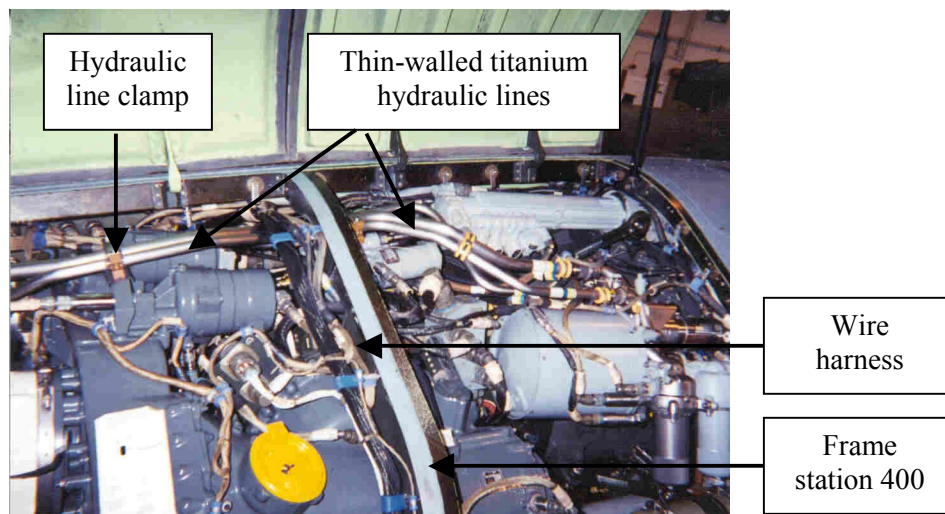
**Figure 2. Outboard Right Nacelle of an LRIP Aircraft**

The V-22 nacelles, located at the end of each wing, house the aircraft's engine and rotor system. The nacelles are densely populated with engine and rotor system components, including actuators, wire harnesses, and lines (including thin-walled titanium hydraulic lines<sup>12</sup>) that are intricately routed and in close proximity to one another. Because the hydraulic system is designed to operate at 5,000 pounds of pressure per square inch, it provides the opportunity to use smaller actuators and allows for a more compact packing of the nacelle. To achieve a lower aircraft weight, thin-walled titanium hydraulic lines are used in the nacelles and other locations throughout the V-22. Figure 2 illustrates the compact and heavily populated environment of the V-22 nacelles and identifies the frame station 400 as well as one of the many hydraulic line clamps, thin-walled titanium hydraulic lines, and wire harnesses within the V-22 nacelles.

VMMT-204 maintenance personnel, the Line Clearance IPT, and the Panel indicated that the hydraulic system problems experienced by the V-22 Program were primarily caused by a compact nacelle design, which made it difficult to minimize the impact of vibration, and a manufacturing variance referred to as “artisan latitude.” Vibration and artisan latitude can result in hydraulic line chafing that degrades the reliability of the hydraulic system.
